MERRIMACK RIVER
BENNINGTON, NEW HAMPSHIRE

MONADNOCK POWER STATION DAM
NH 00249

PHASE I INSPECTION REPORT
NATIONAL DAM INSPECTION PROGRAM

FEBRUARY 1979

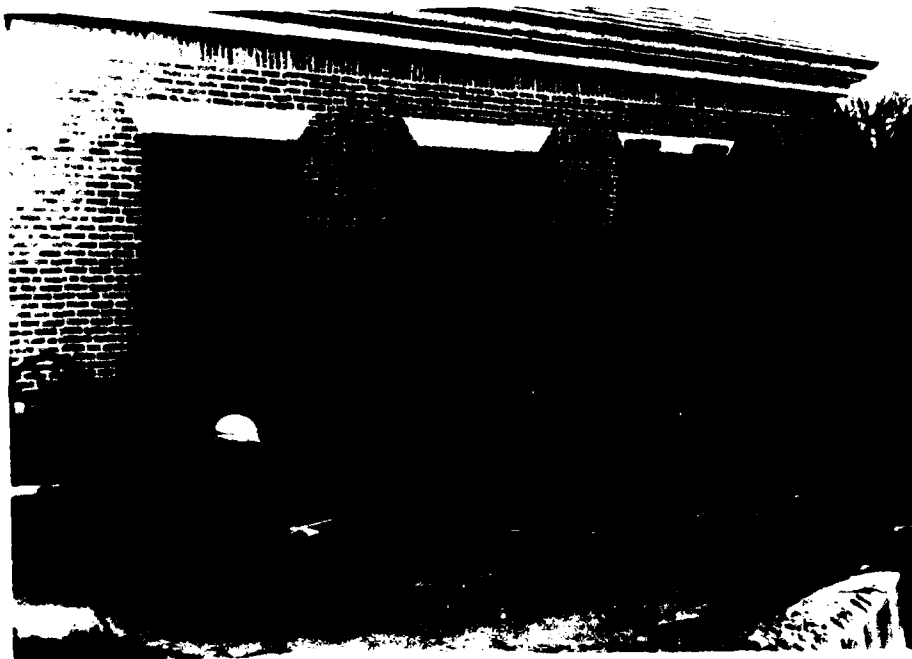
c. Appurtenant Structures. The dam gate structure is located on the upstream face of the powerhouse and is constructed integral with the powerhouse. (See Appendix C - Figure 5.) The exposed portions of the concrete gate structure have several areas of spalling and deterioration. (See Appendix C - Figure 6.) The leading edge of the concrete deck has spalled and the concrete has eroded exposing the reinforcing steel. Efflorescence was also observed on the upstream vertical face of the gate structure. The visible portion of the wooden gates and manual gate operating mechanism were observed to be in good condition. One hand crank was broken. (See Appendix C - Figure 7.)

Figure 5 - Looking at the gate structure on the upstream side of the powerhouse.

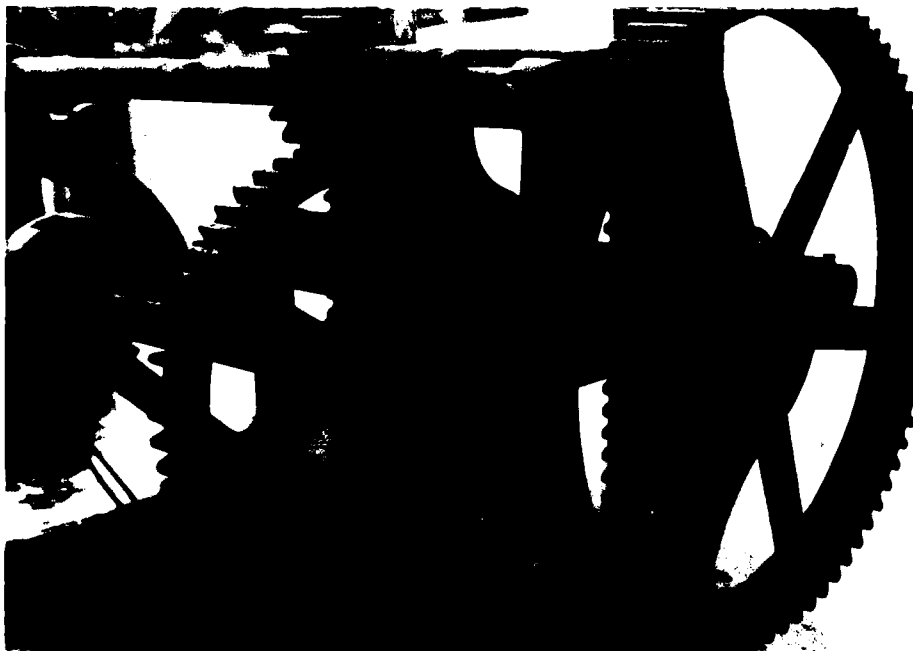
Figure 7 - Looking at the broken hand wheel operating mechanism.

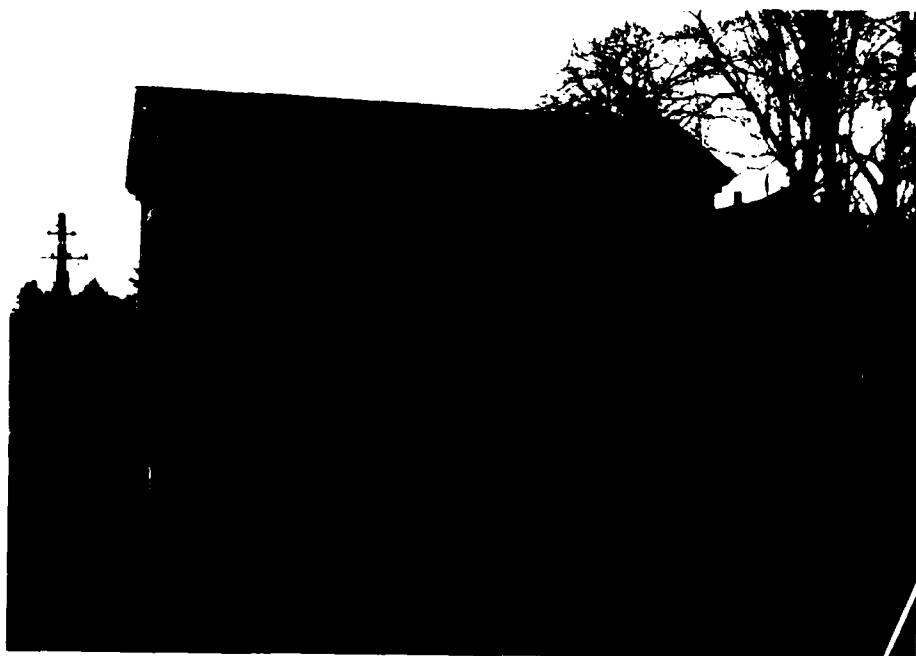
The downstream face of the powerhouse was observed to have numerous hairline cracks and areas of deterioration. (See Appendix C - Figures 8 and 9.) Efflorescence was noted emanating from the cracks. No indication of movement of the structural elements was observed.

Figure 8 - Looking at the downstream face of the powerhouse. Note the numerous areas of deterioration.

c. Design and specify remedial repairs for the deteriorated concrete in the appurtenant structures and in the dam if found to be deteriorated, after inspection when water is not flowing over the dam.
